SR 26 / University Avenue Multimodal Emphasis Corridor Study

DRAFT Phase 2 Report

May 2015

**Metropolitan Transportation Planning Organization
for the Gainesville Urbanized Area**

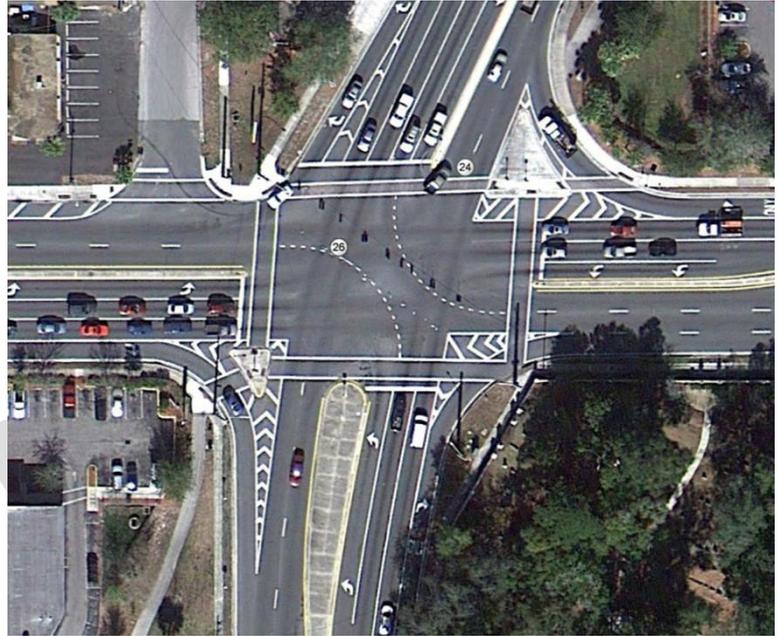
Figure 1 SR 26 at Waldo Road Existing Configuration

The existing configuration of the intersection of SR 26 and Waldo Road is shown in Figure 1. There were two specific comments regarding this intersection made during the Technical Advisory Committee (TAC) walking tour (preliminary Phase 1 field assessment). The first was that the southeast corner of the intersection includes a free-flow (uncontrolled) right turn lane across two *signalized* crosswalks. The second comment was that the pedestrian crossings are quite long.

The uncontrolled right turn across the two signalized crosswalks results in pedestrians receiving a WALK signal when the vehicles are under free-flow operations. Essentially, this tells pedestrians they are permitted to start to cross the roadway in the direction of the signal indication. While crossings with a WALK signal can occur with conflicting turning vehicles, those vehicles approaching from a perpendicular or near perpendicular direction normally have a red signal. Thus pedestrians may reasonably expect the vehicle operators turning right from the direction that has the red traffic signal (or at least the through movements have a red traffic signal) to be required to stop and yield prior to making a right turn on red. However, under the existing condition on the southeast corner of this intersection, there is nothing to inform the free-flow north-to-east right turning motorists that the pedestrian's traffic control has changed. This could lead to confusion and safety issues at this intersection.

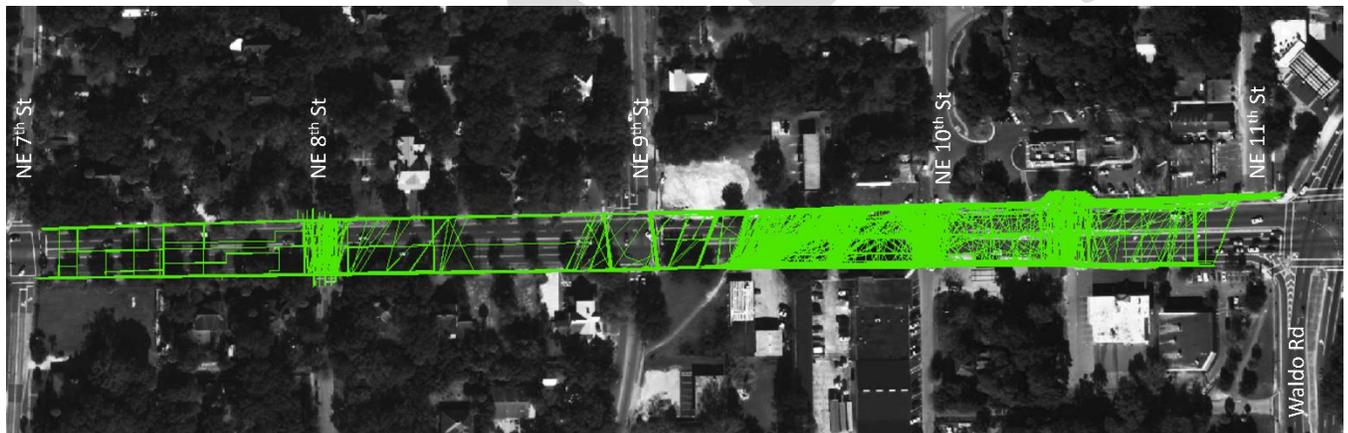
Figure 4 Pedestrian Paths Mapped between E 7th St and Waldo Rd

SR 26 from E 7th Street to the beginning of the raised median east of 10th Street was video recorded to map pedestrian movements. Data was collected for the Thursday, Friday, and Saturday, February 5-7, 2015. Visibility during the 0:00-2:00 hours on February 5th were sub-optimal due to rain. 1,340 pedestrian movements in which pedestrians crossed SR 26 were mapped (Figure 4). These pedestrian crossings fell into several categories.

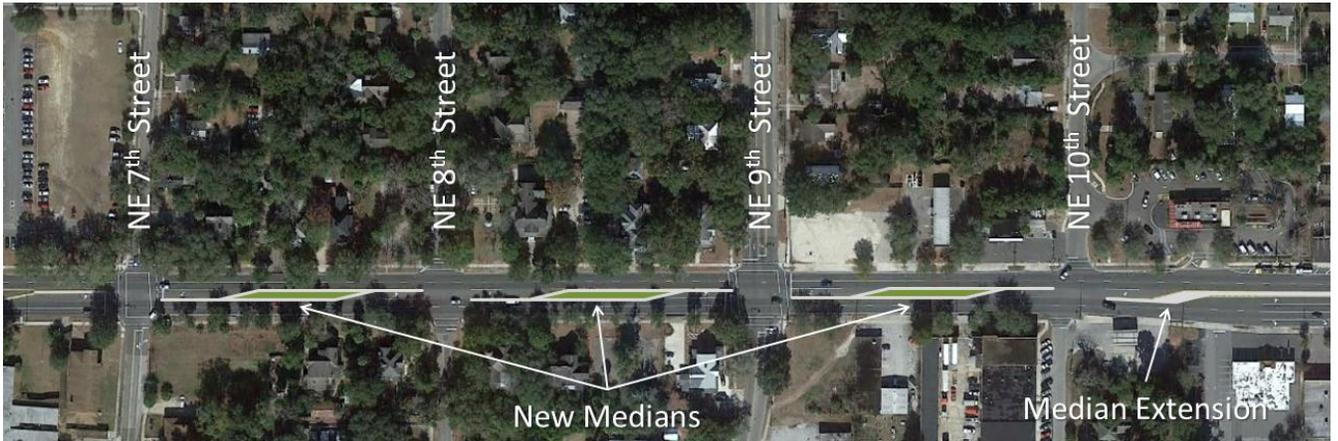
Figure 8 Recommended Medians between 7th Street and 10th Street

Given the above, a raised median is recommended to be installed between E 7th Street and the existing median east of E 10th Street. Between E 7th Street and E 9th Street, the FDOT Straight Line Diagram indicates this section of roadway has four 12-foot lanes and a 13-foot painted turn lane. Narrowing the travel lanes to 11 feet would allow for the provision of a 17-foot median where there are currently two-way left turn lanes and a 6-foot traffic separator where there are dedicated left turn lanes (which would be 11 feet wide). The 2015 revision of the FDOT *Plans Preparation Manual* (Table 2.1.1) specifies lane widths of 11 feet for divided urban arterials with design speeds of 45 mph or less. East of E 10th Street the median could widen to encompass the current painted median (Figure 8). The existing and proposed cross sections are shown in Figure 9.

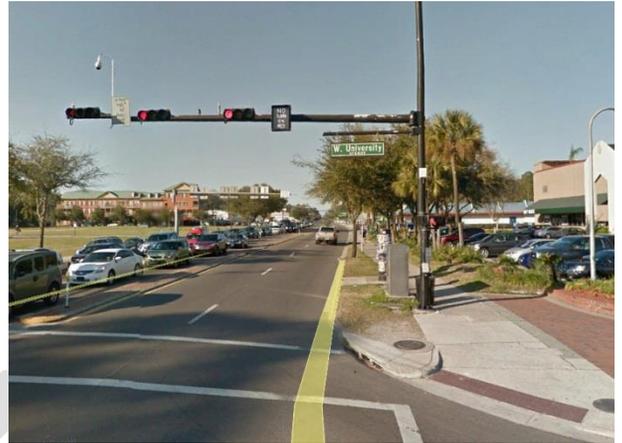
Figure 12 No RIGHT ON RED Blank Out Sign at SR 26 and 13th Street

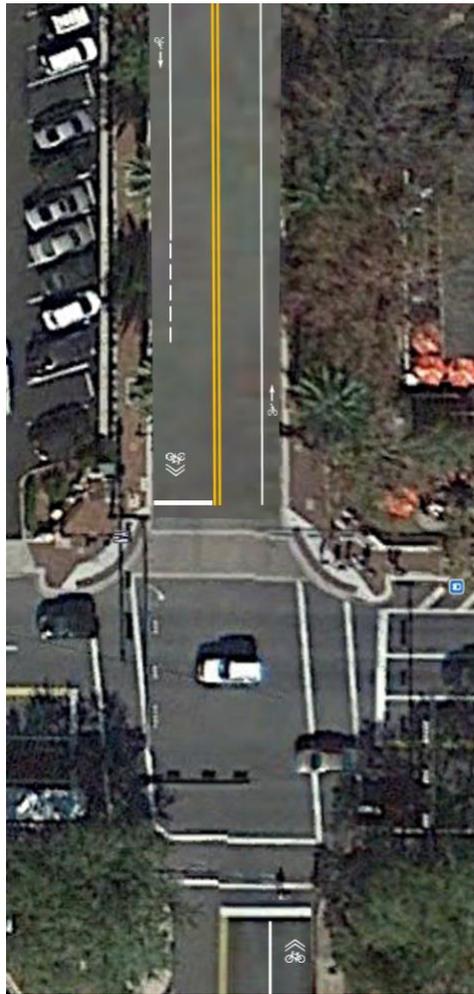
Figure 14 Potential Markings for NW 17th Street and SW 17th Street

The recommendation for this location is for the bike lane to be terminated in advance of the intersection and SHARED LANE MARKINGS installed on the final approach. Alternatively, the BICYCLE DETECTOR could be used instead of a SHARED LANE MARKING. Both the north and south approaches could have either marking placed at the intersection to both inform the bicyclists of where to place their bicycles to be detected by the signals and to encourage them to move their bicycles further into the through lanes. This marking pattern is shown in Figure 14. The SHARED LANE MARKING may be more familiar to Gainesville residents and thus be a better symbol to use.

- modification of the southbound bike lane striping, and
- installation of BICYCLE DETECTION (OR SHARED LANE MARKINGS) on the north and south approaches to the intersection.

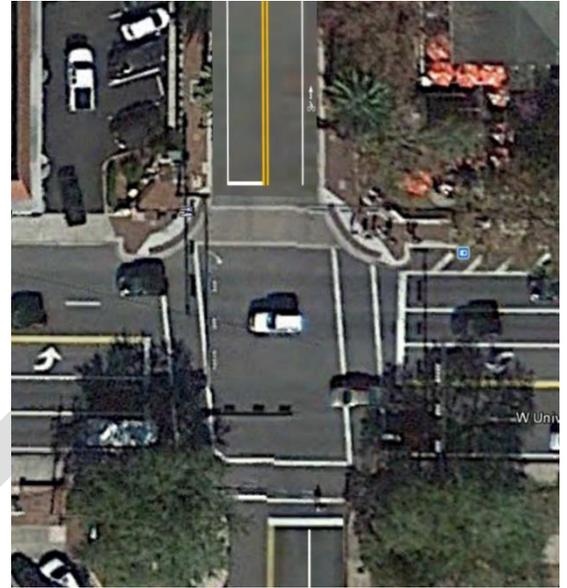
Figure 13 NW 17th Street and University Existing Markings

The northern approach to this intersection has the bike lane striped all the way to the stop line. This solid-stripe-to-the-intersection striping is inconsistent with the MUTCD, the AASHTO *Bike Guide*,⁵ and the Florida *Greenbook*.⁶ Also, a solid line separating the bike lane from the general lane at an intersection discourages motorists from approaching the intersection and turning right from “as close as practicable to the right-hand curb or edge of roadway.”⁷ This movement to the right is required by Florida’s uniform traffic laws. It also encourages bicyclists making a through movement to stay on the right side of the pavement all the way up to the intersection. The combination of these behaviors encourages “right hook” type conflicts. The (approximate) existing striping is shown in Figure 13.

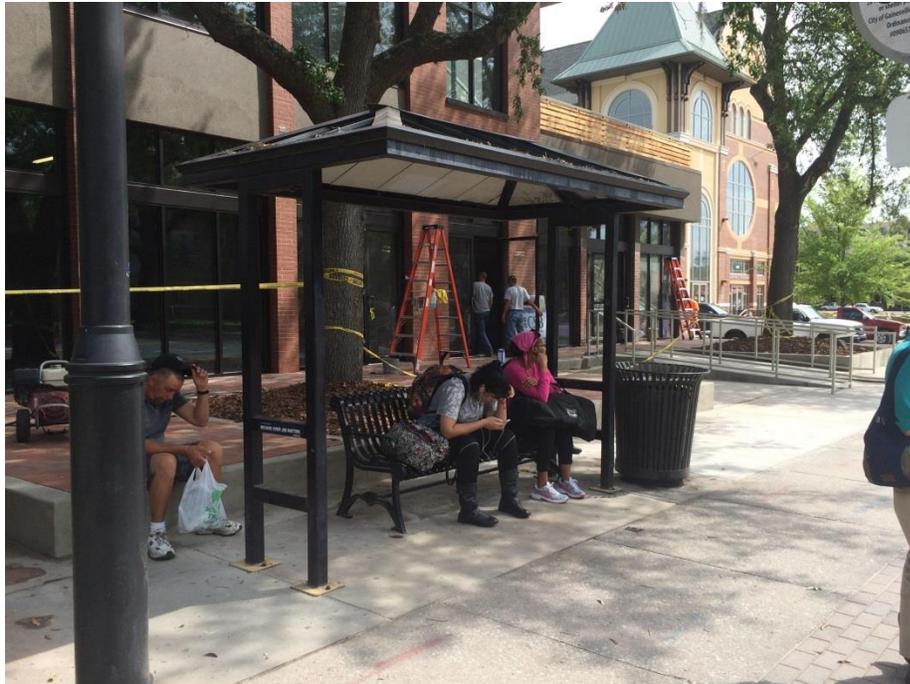
Figure 19 Photo of existing shelter at RTS stop located on westbound SR 26 at NW 14th Street

Figures 19 and 20 show typical configurations of a small RTS bus stop shelter.

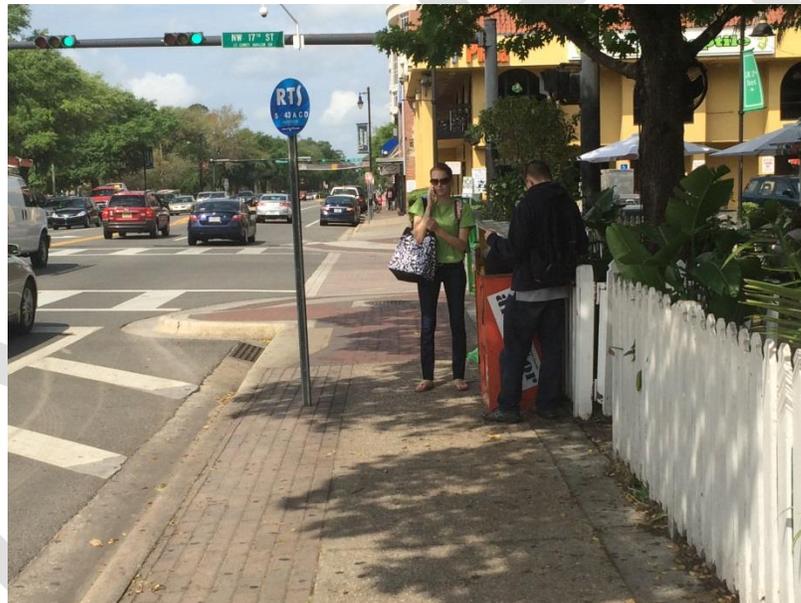
Figure 22 Photo looking west from RTS stop located on westbound SR 26 at NW 17th Street

This stop is located about 80 feet away from the nearest overhead light source. There is no opportunity, with the existing stop layout, to locate the stop closer to the overhead light due to the proximity to the crosswalk and intersection. Therefore, the level of lighting is not adequate and the installation of a lighted shelter is recommended.

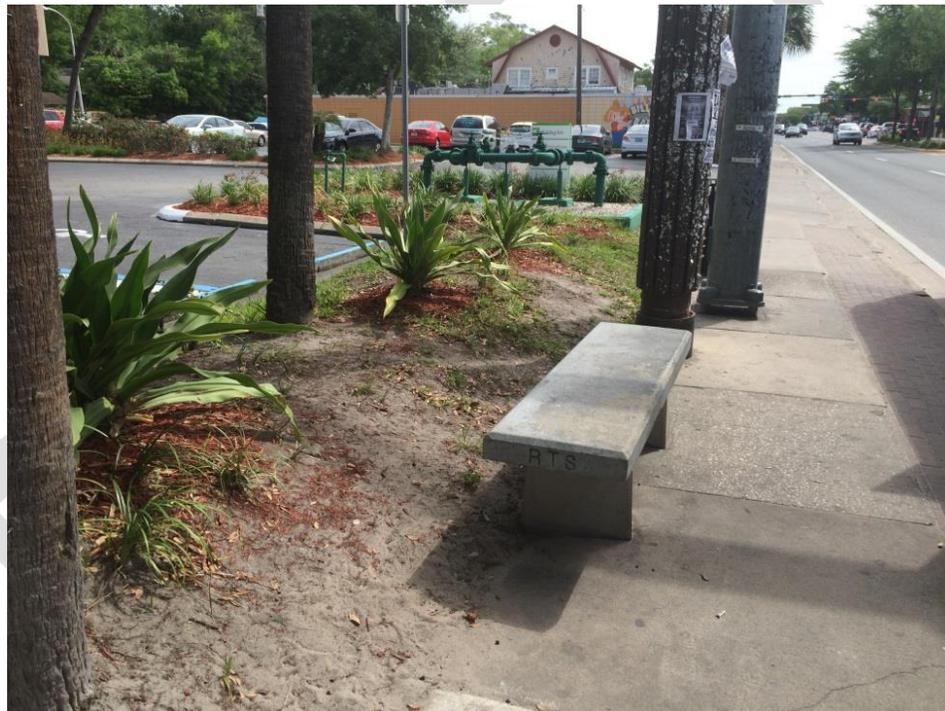
Figure 24 Photo looking east from RTS stop located on westbound SR 26 at NW 13th Street

This stop is located about 30 feet away from the nearest overhead light source. However, the roof of the shelter could block the light and the installation of a lighted shelter is recommended.

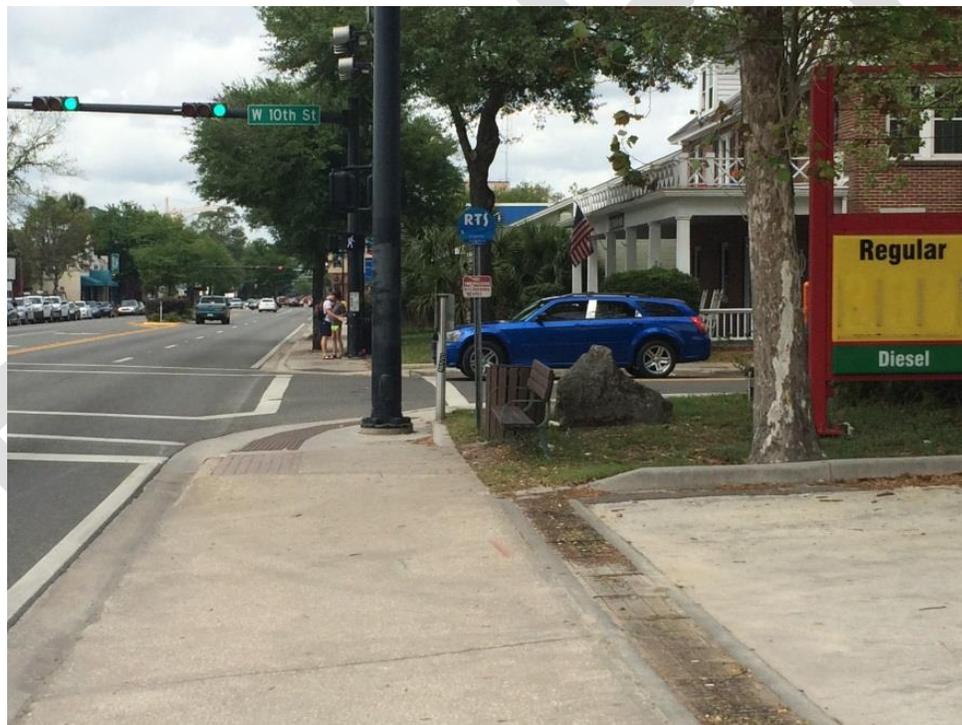
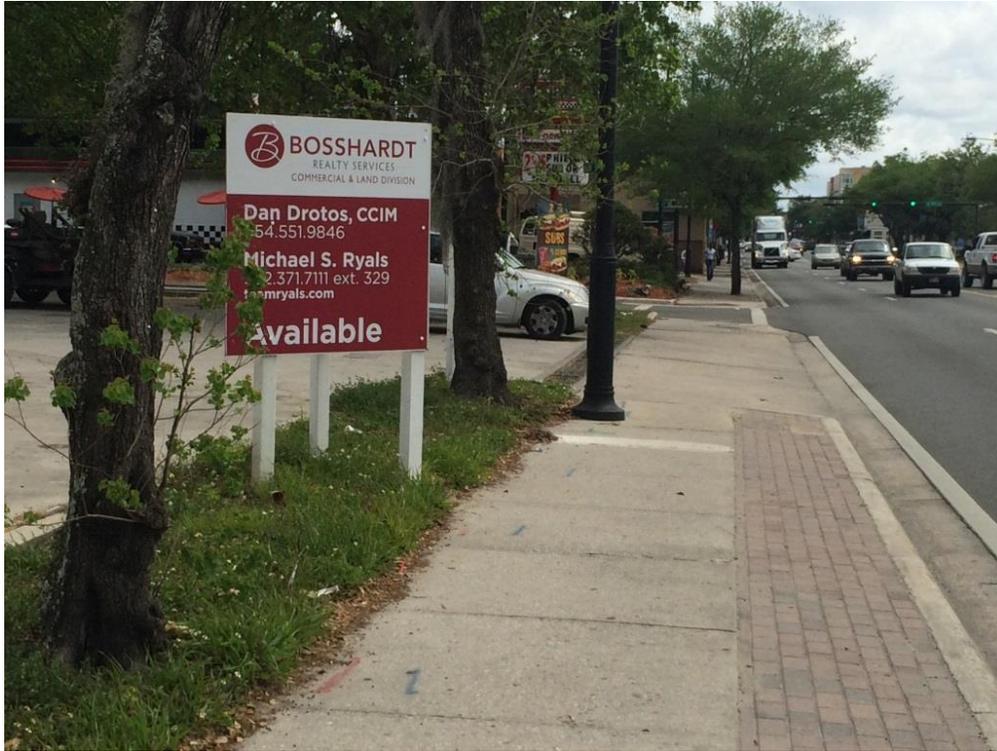
Figure 25 Photo looking west from RTS stop located on westbound SR 26 at NW 10th Street

This stop is located next to an overhead light source and thus the level of lighting is adequate. If the stop were to be moved as recommended for the shelter installation, there is another overhead lighting source; however, the roof of the shelter could block the light and the installation of a lighted shelter is recommended.

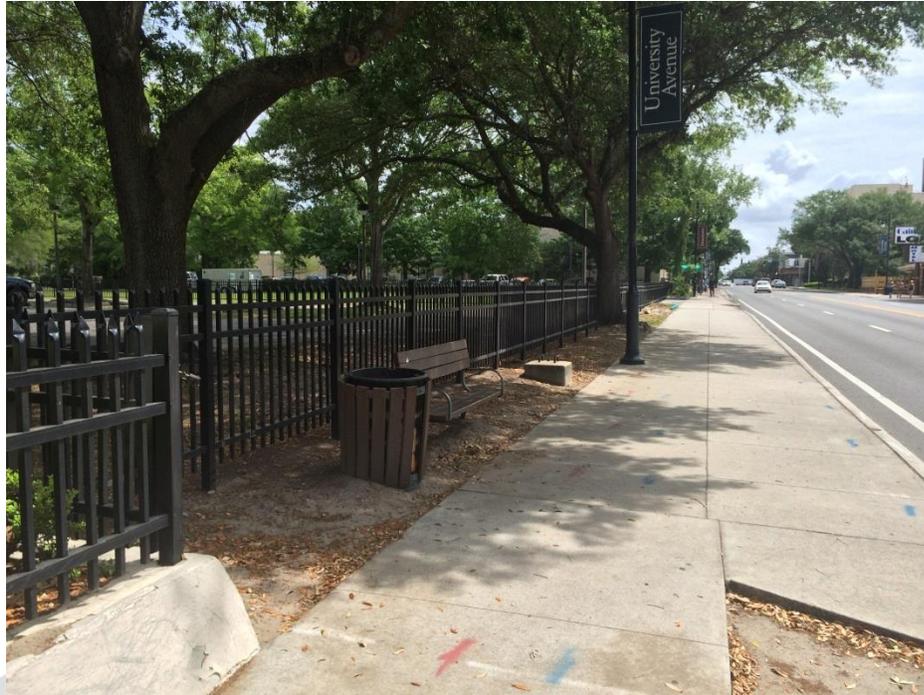
Figure 27 Photo looking east from RTS stop located on westbound SR 26 at NW 6th Street

This stop is located about 15 feet away from the nearest overhead light source. However, the existence of an extensive tree canopy could block the light and the installation of a lighted shelter is recommended.

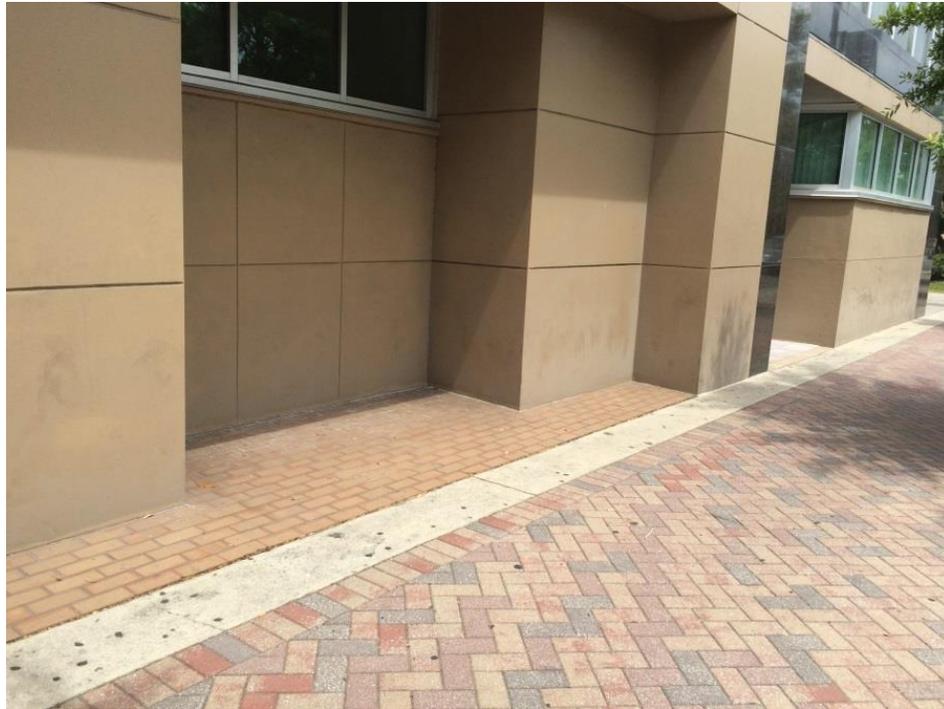
Figure 29 Photo looking east to building opening area next to RTS stop located on westbound SR 26 at NW 1st Street

- Move the bus stop to the east where there is a building opening area of about 9 feet long as shown in Figure 29. However, the spacing is not adequate for the shelter concrete pad required for the smallest RTS shelter. The possibility of hanging an awning off the building should be further evaluated. The awning could block the light and the installation of additional lighting is recommended.

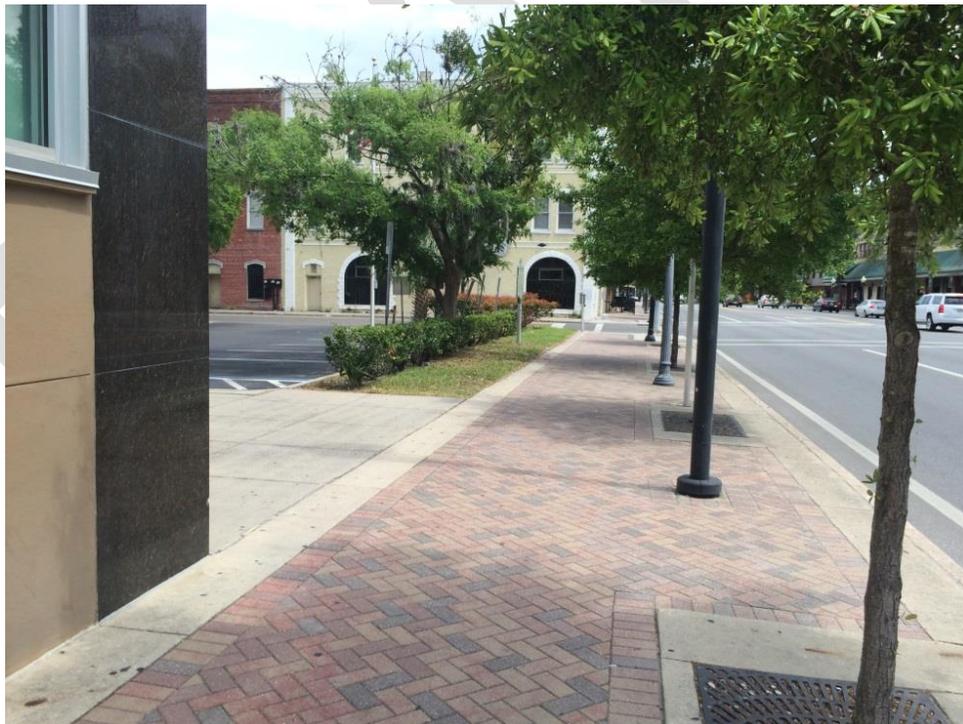
Figure 30 Photo looking east parking lot area next to RTS stop located on westbound SR 26 at NW 1st Street

- Move the bus stop further to the east next to the parking lot area shown in Figure 30. The space between the curb and the parking lot provides the opportunity for the installation of a bus shelter that can extend into the sidewalk if needed. There is an existing historical marker in the grass area that might have to be relocated slightly to the east to accommodate a shelter. There is an overhead light source at this location; however, the roof of the shelter could block the light and the installation of a lighted shelter is recommended.

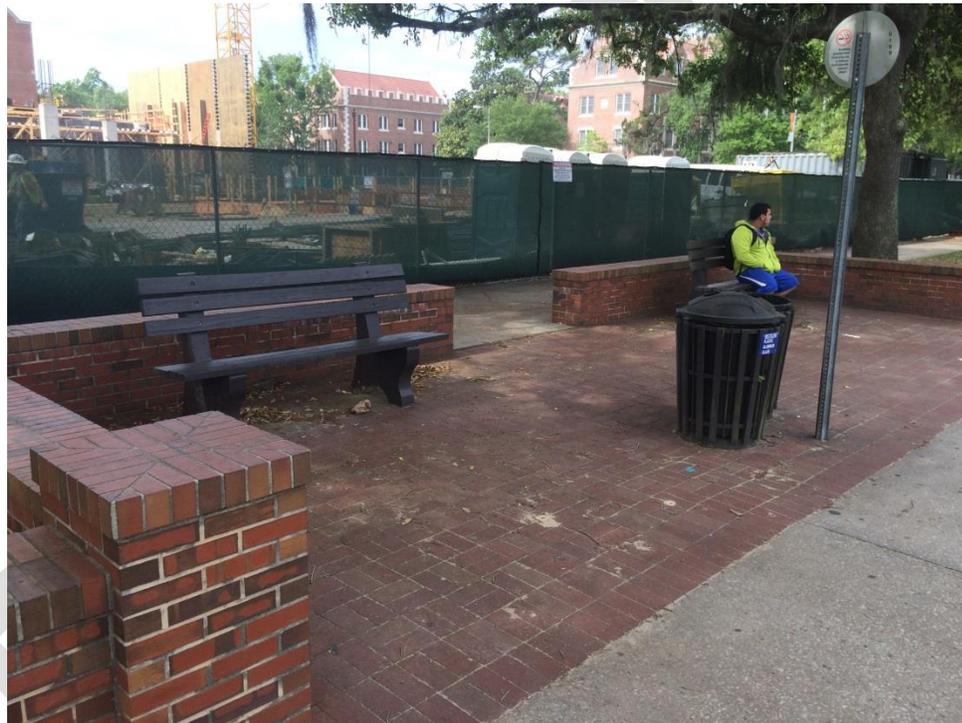
Figure 31 Photo looking west from RTS stop located on eastbound SR 26 at Buckman Drive

This stop is located about 100 feet away from the nearest overhead light source. Therefore, the level of lighting is not adequate and the installation of a lighted shelter is recommended.

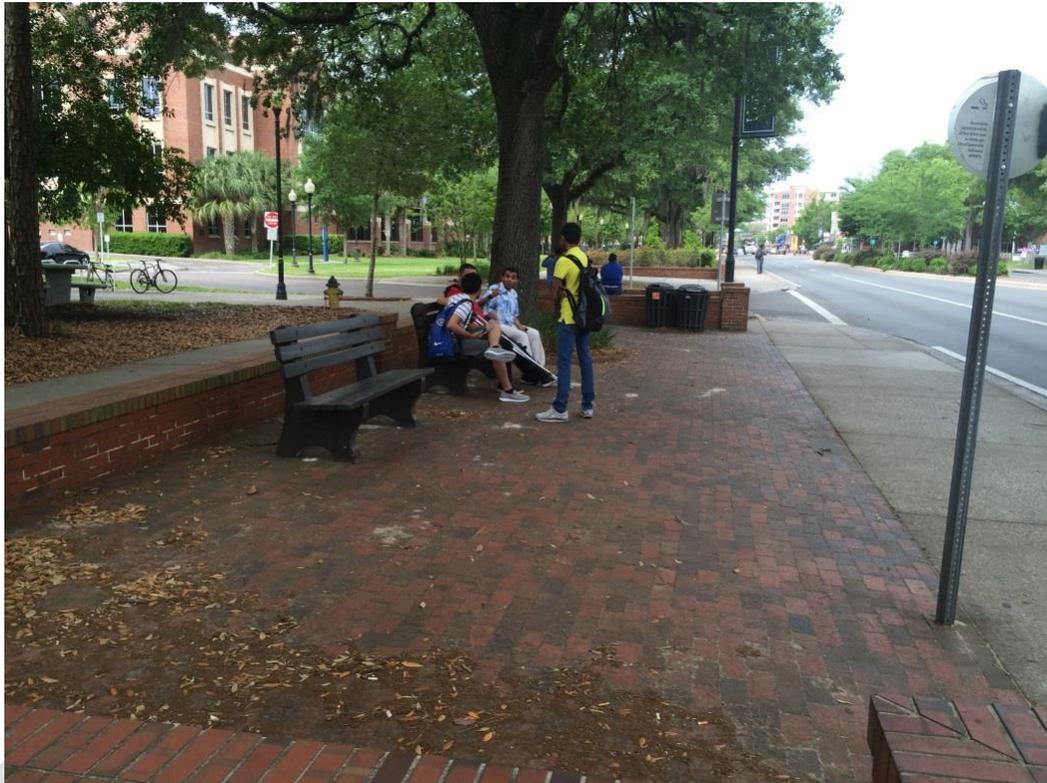
Figure 32 Photo looking west from RTS stop located on eastbound SR 26 at NW 15th Street

This RTS stop serves the University of Florida area (Figure 32). There is a similar opportunity for installation of a bus stop shelter at this location as observed at the RTS stop located on eastbound SR 26 at Buckman Dr.

This stop is located about 12 feet away from the nearest overhead light source but the presence of extensive tree canopy could block the light. Therefore, the installation of a lighted shelter is recommended.

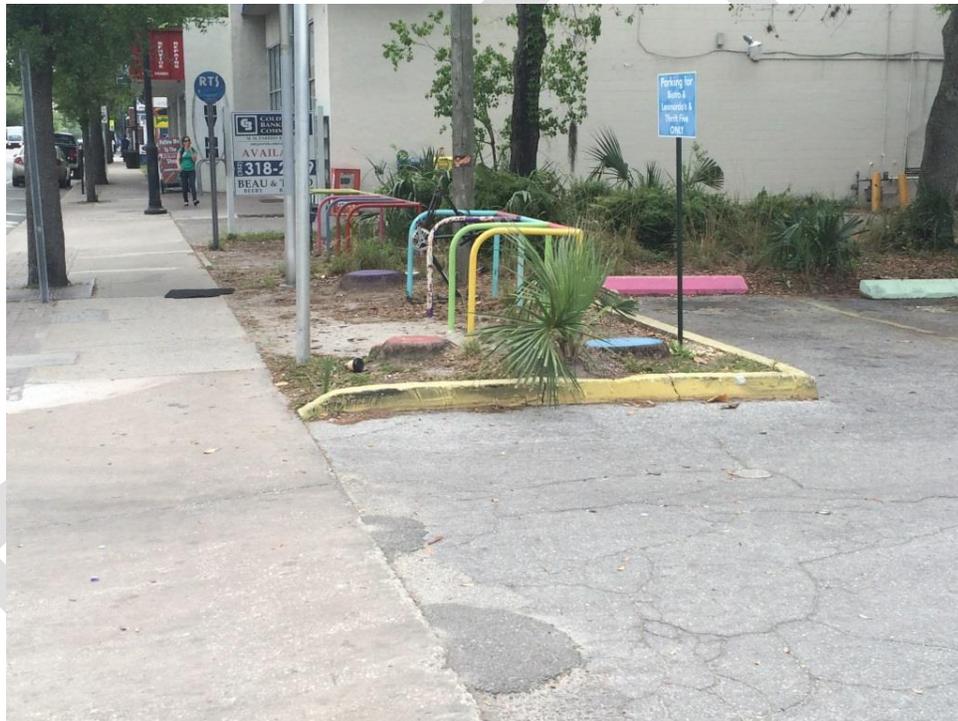
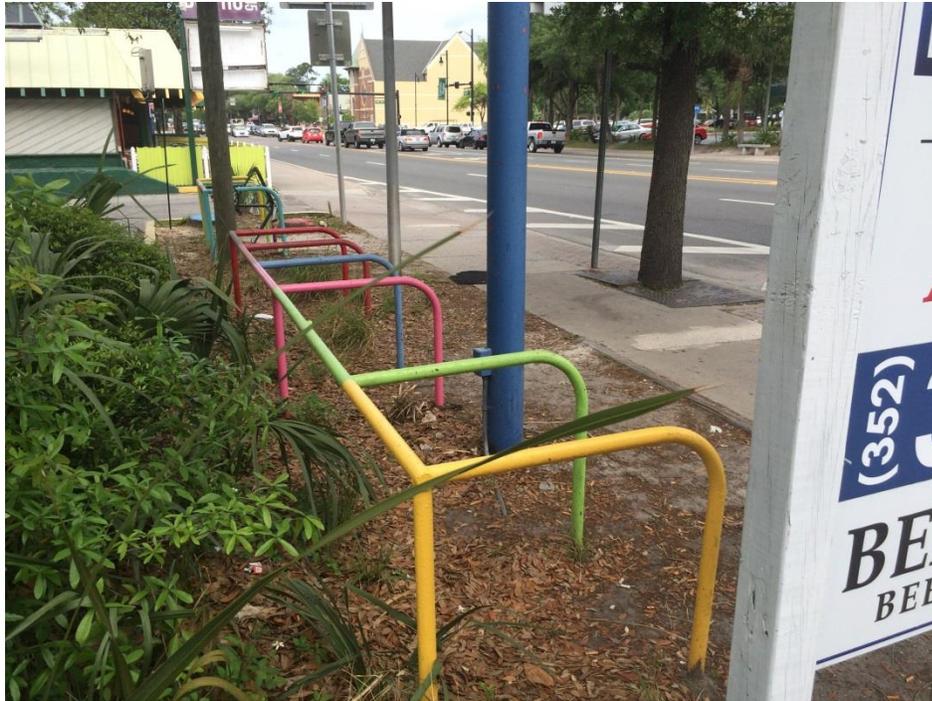
Figure 33 Photo looking east from RTS stop located on eastbound SR 26 at SW 13th Street

This stop is located about 30 feet away from the nearest overhead light source but the roof of the shelter could block the light. Therefore, the installation of a lighted shelter is recommended.

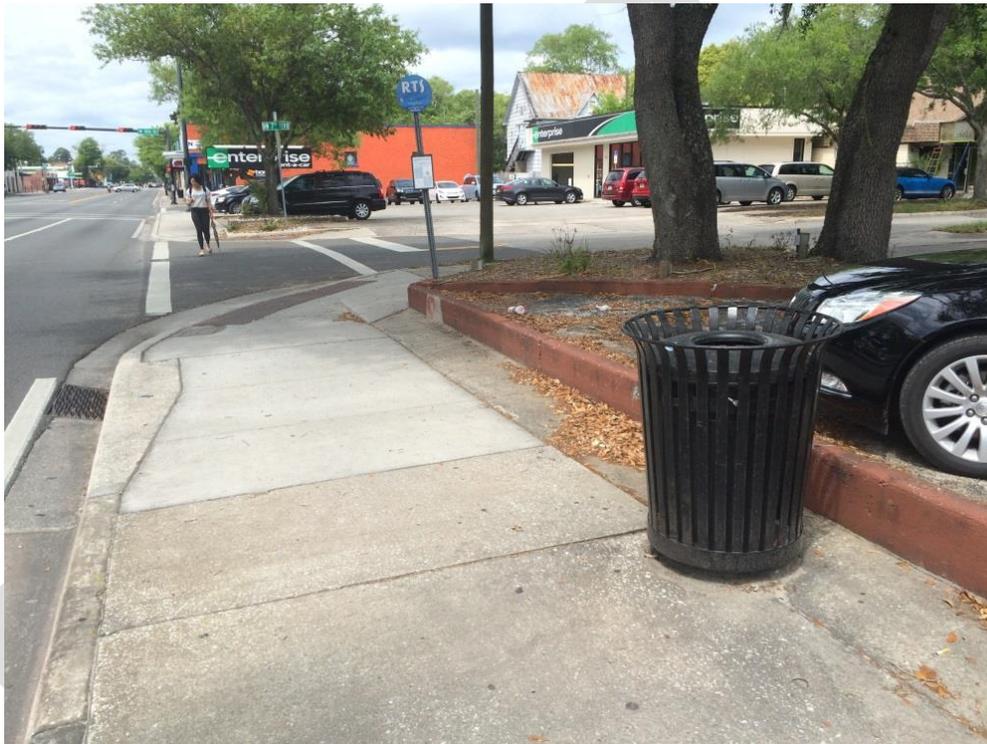
Figure 35 Photo looking west from RTS stop located on westbound SR 26 at NW 7th Terrace

This RTS stop serves a commercial area. There is adequate space within the sidewalk for a bus stop bench placement (Figure 35). Considerations to move the bus stop more towards the east away from the intersection for passenger safety is recommended. RTS indicates the bus currently stops to pick up passengers prior to the RTS bus stop sign; the sign location was chosen because it was the only location that did not require drilling the sign into concrete.

This stop is located about 60 feet away from the nearest overhead light source. Therefore, the level of lighting is not adequate and the installation of a new overhead light source no more than 30 feet from the bus stop is needed.

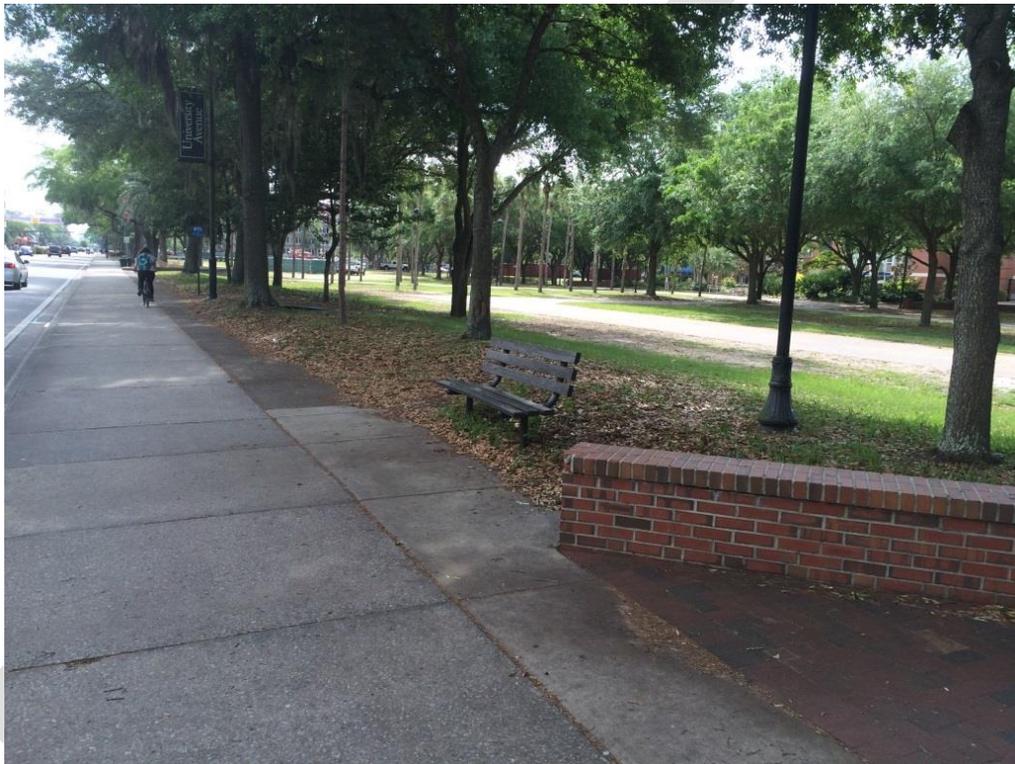
Figure 36 Photo looking east from RTS stop located on eastbound SR 26 at Gale Lemerand Drive

This stop is located about 15 feet away from the nearest overhead light source but the presence of an existing tree canopy could block the light. Therefore, the level of lighting might not be adequate.

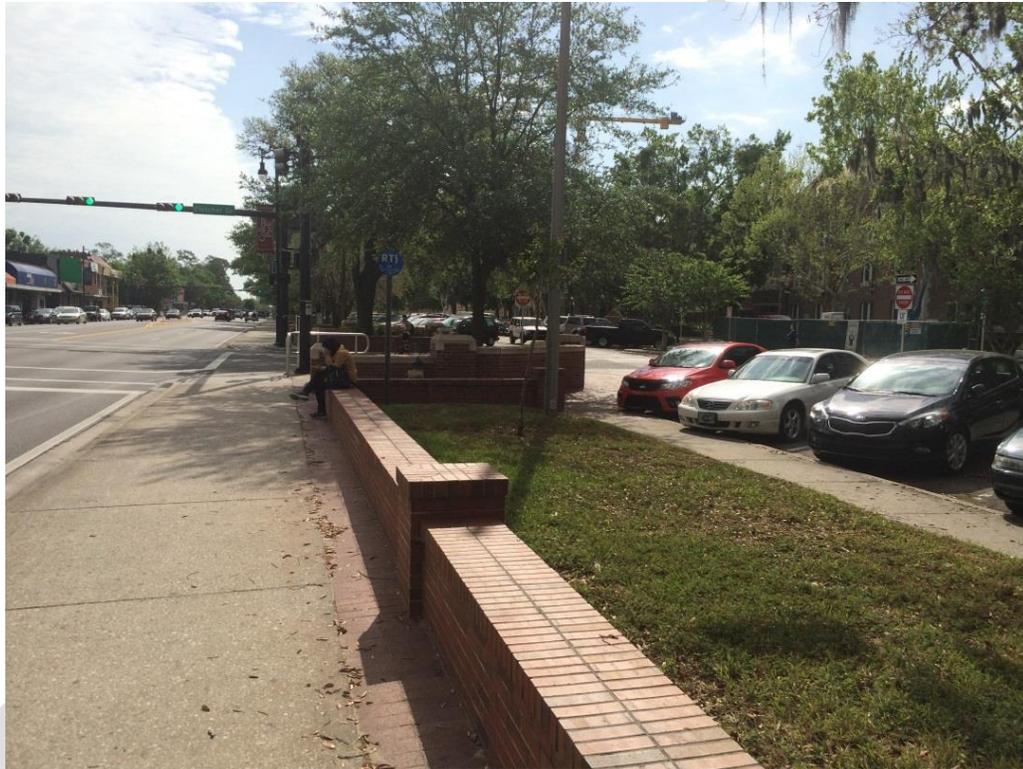
Figure 37 Photo looking east from RTS stop located on eastbound SR 26 at Fletcher Drive

There is an overhead light source located behind to the RTS stop; however, the luminaria is directed to the parking lot area. Therefore, the level of lighting might not be adequate.

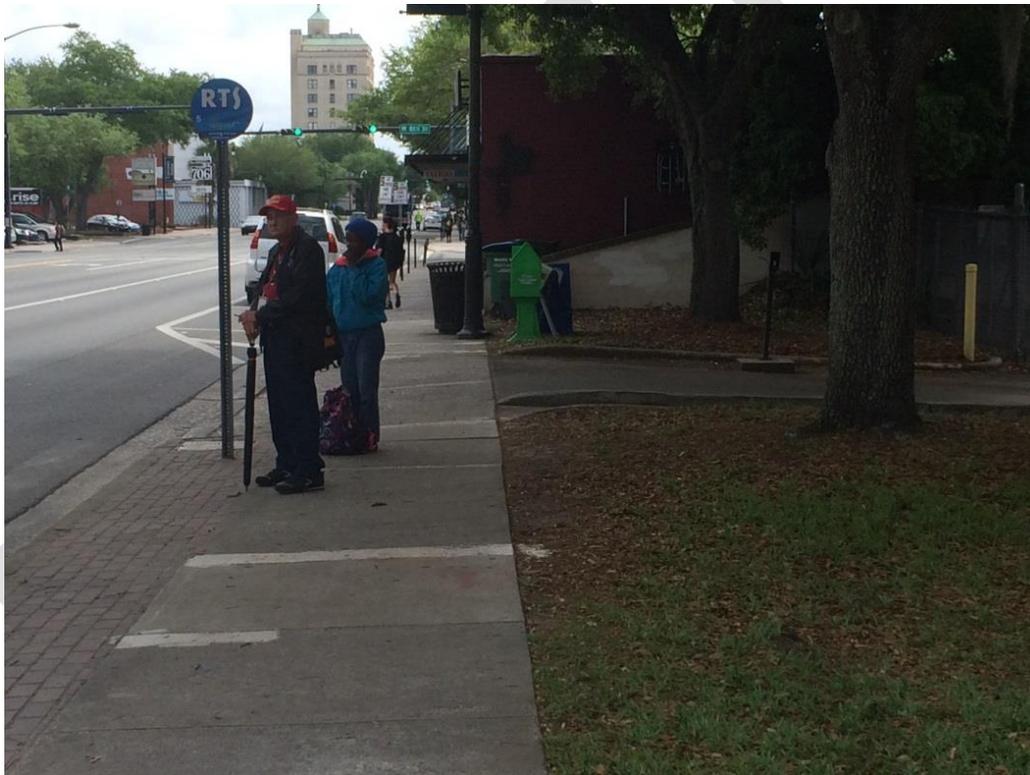
Figure 38 Photo looking east from RTS stop located on eastbound SR 26 at 9th Terrace

This stop is located about 30 feet away from the nearest overhead light source. Therefore, the level of lighting is adequate.
